SEPTEMBER, 1979

Name Of Dam: MOSS NO. 1 DAM
Location: DICKENSON COUNTY, VIRGINIA
Inventory Number: VA. NO. 05102

PHASE I INSPECTION REPORT

NATIONAL DAM SAFETY PROGRAM

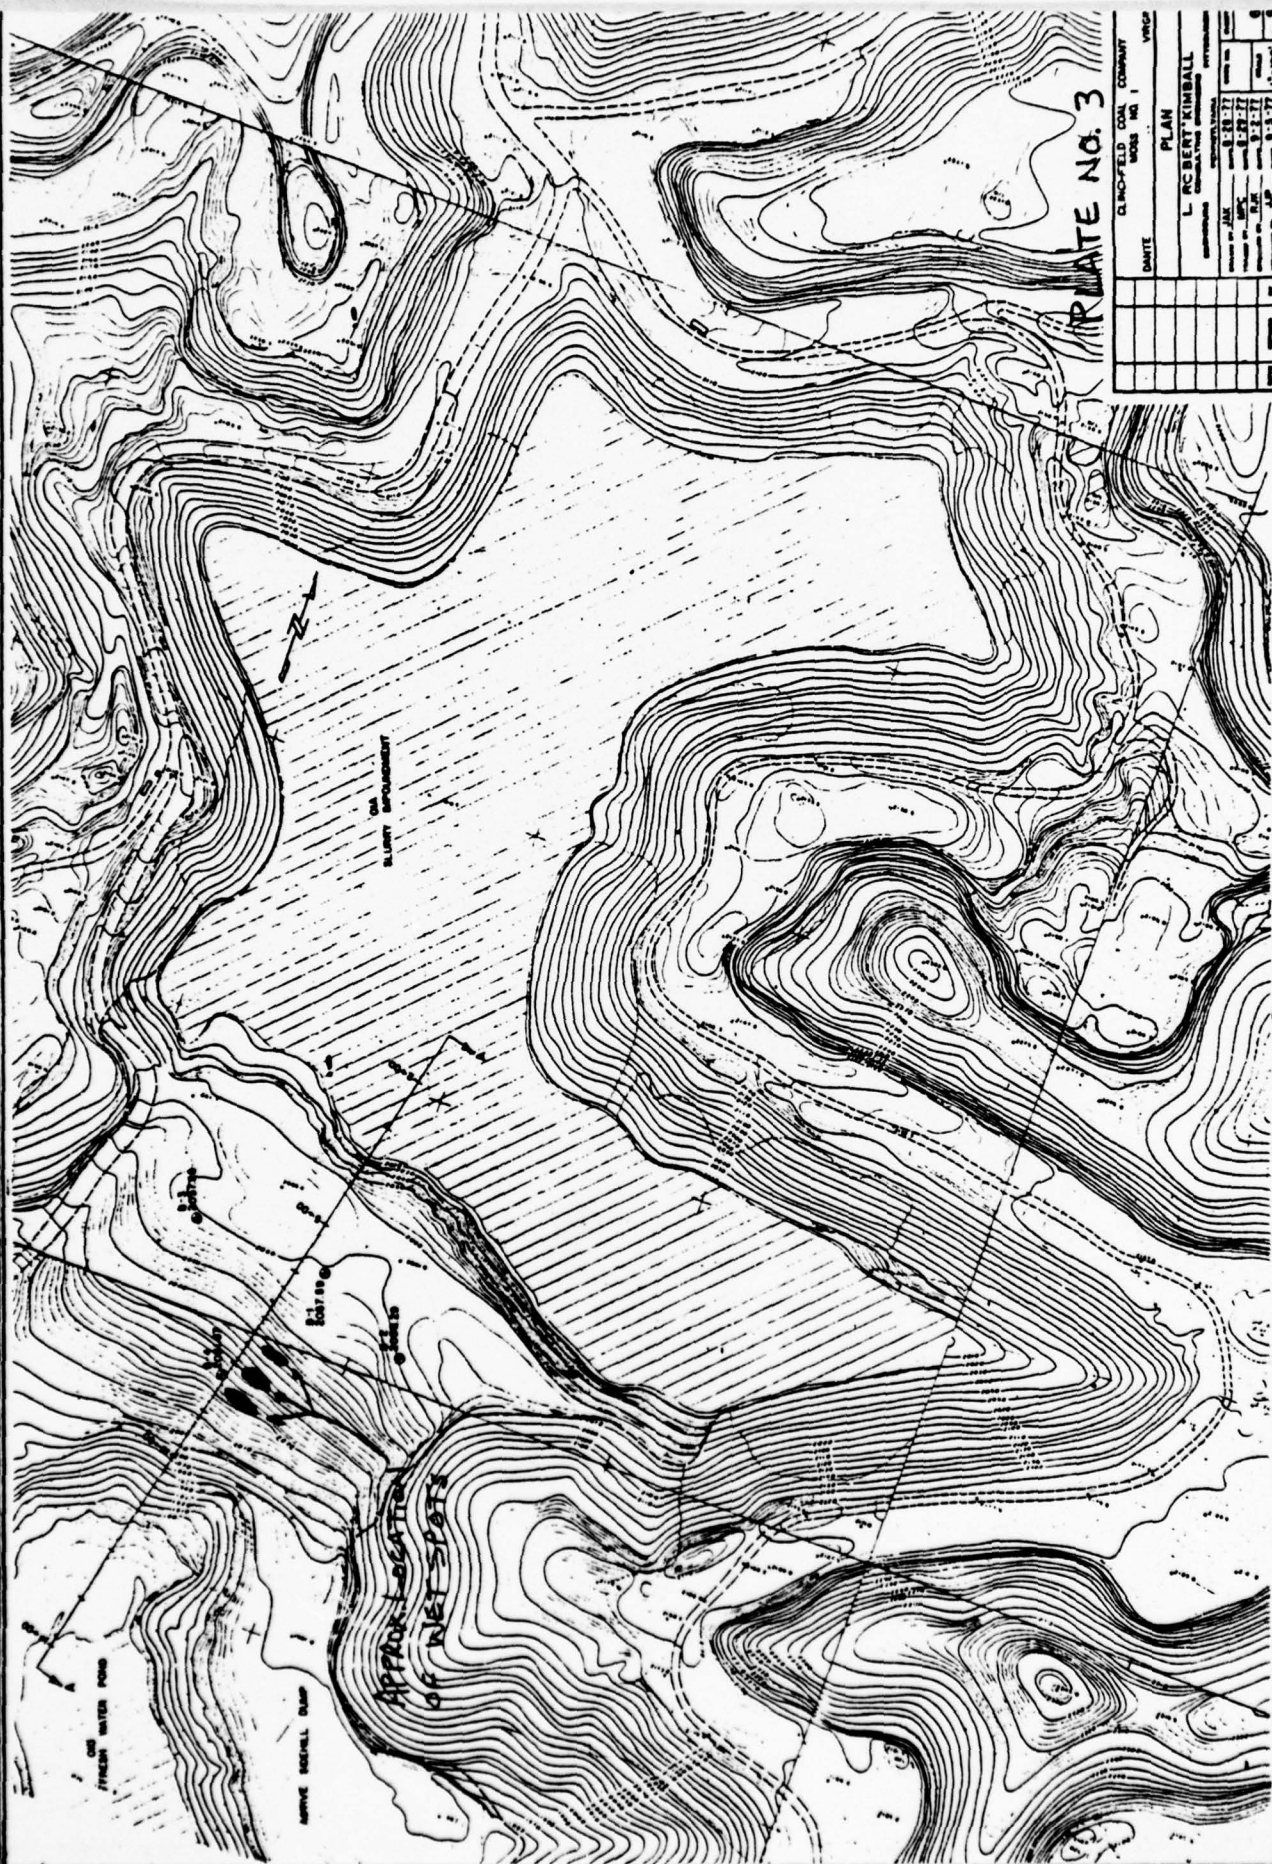
Wet spots were observed at three locations (Plate 3, Appendix I) on the downstream slope. The wet spots are reportedly the result of surface water percolating into the embankment above and seeping out horizontally along old haul road surfaces, which are now covered with coarse coal refuse.

Water observation well readings varied from 105 to 176 ft below the top of the dam (See 7.2, Appendix III). The data indicates the water level is located in the slurry below the coarse coal refuse and in the weathered and fractured bedrock.

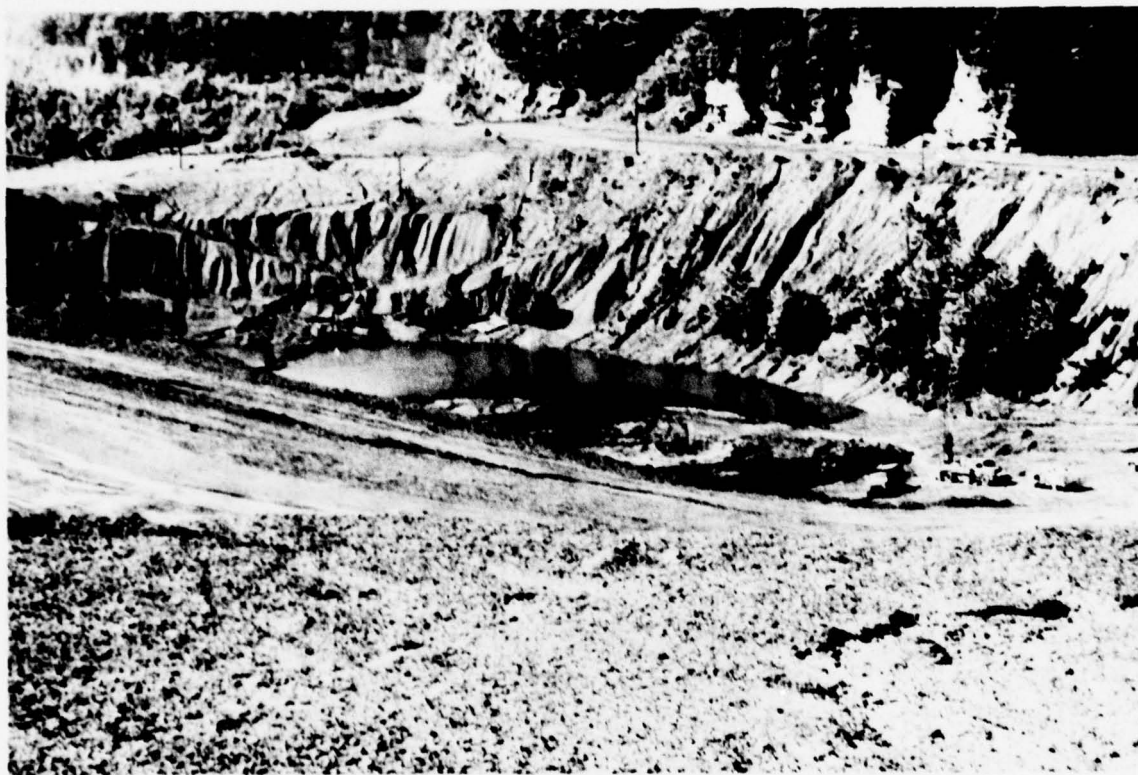
VIEW FROM TOP OF IMPOUNDMENT LOOKING TOWARD FRESH WATER POND AT
BASE OF MOSS MINE NO. 1 IMPOUNDMENT.

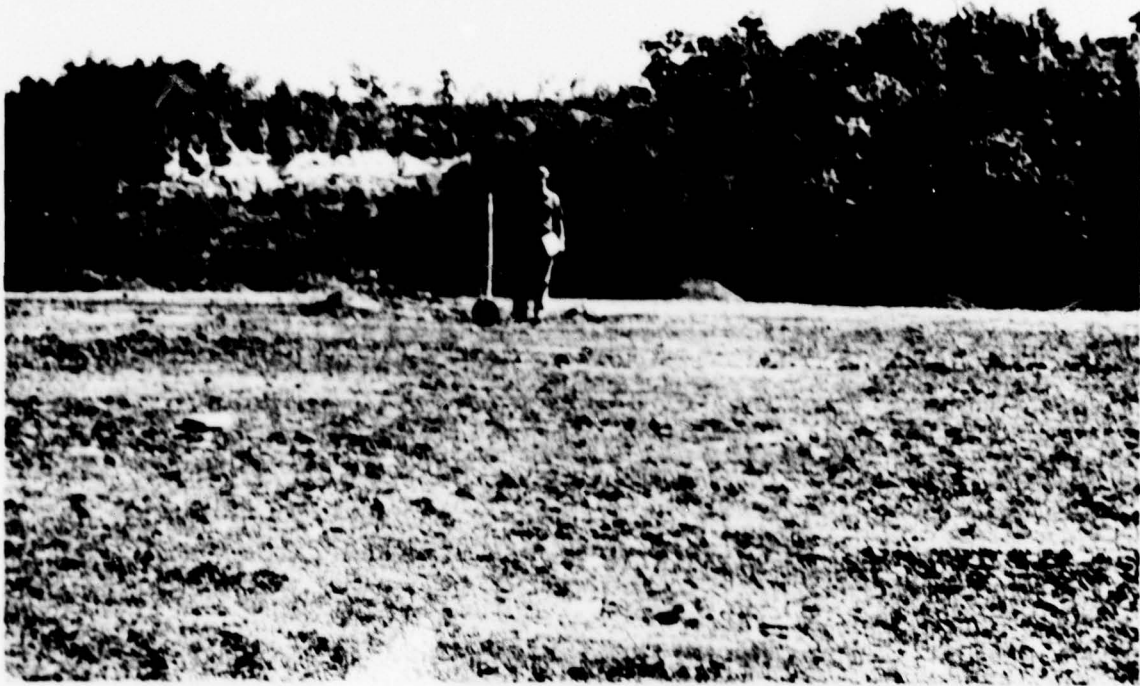
VIEW ACROSS TOP OF IMPOUNDMENT SHOWING OBSERVATION WELL

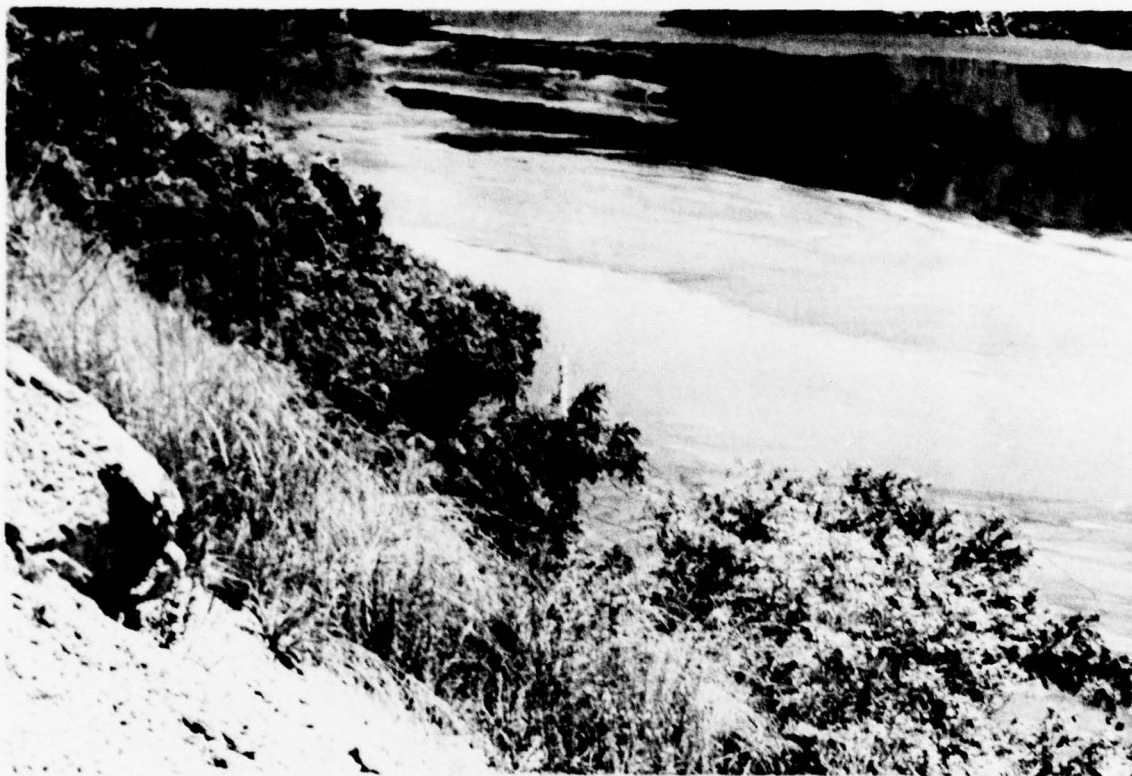
STAFF GAGE AND SIDE SLOPES OF RESERVOIR
